Contract #: 04-0120F4Cty: SF/ALA Rte: 80 PM: 13.2/13.9File #: 69.28**WELDING INSPECTION REPORT****Resident Engineer:**Siegenthaler, Peter**Address:** 333 Burma Road**City:** Oakland, CA 94607**Report No:** WIR-017299**Date Inspected:** 01-Oct-2010**Project Name:** SAS Superstructure**OSM Arrival Time:** 1900**Prime Contractor:** American Bridge/Fluor Enterprises, a JV**OSM Departure Time:** 700**Contractor:** Zhenhua Port Machinery Company, Ltd (ZPMC), Changxing Island **Location:** Shanghai, China**CWI Name:** See Below**CWI Present:** Yes No**Inspected CWI report:** Yes No N/A**Rod Oven in Use:** Yes No N/A**Electrode to specification:** Yes No N/A**Weld Procedures Followed:** Yes No N/A**Qualified Welders:** Yes No N/A**Verified Joint Fit-up:** Yes No N/A**Approved Drawings:** Yes No N/A**Approved WPS:** Yes No N/A**Delayed / Cancelled:** Yes No N/A**Bridge No:** 34-0006**Component:** OBG & Tower**Summary of Items Observed:**

**OBG Segment Trial Assembly**

**Bay 11**

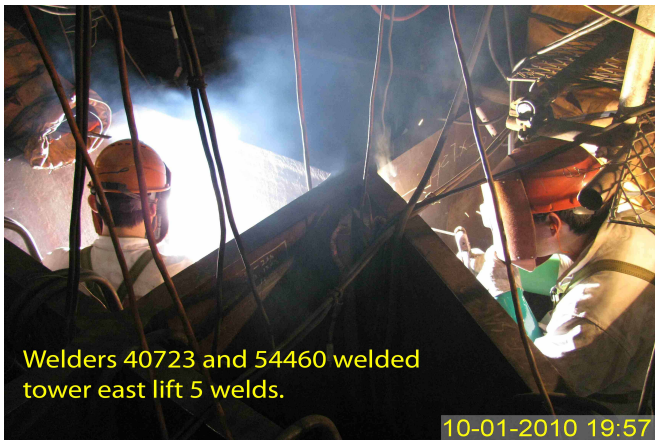
This QA Inspector observed ZPMC welder Mr. Zhao Guiting, stencil 040723 used shielded metal arc procedure WPS-345-SMAW-3G(3F)-Repair to make repair weld ESD1-TL5-2B/F-7A/B. ZPMC CWI Ms. Yu Dong Ping informed this QA Inspector that this work is being performed in accordance with weld repair document T-WR3693. This weld was located on an east tower lift 5 internal connection plate. This QA Inspector observed ZPMC has electric heating elements to preheat and maintain the base material temperature during this welding. This QA Inspector measured a welding current of approximately 160 amps and Mr. Zhao Guiting appeared to be certified to make this weld. Items observed on this date appeared to generally comply with applicable contract documents.
